Manhole Inspection Summary

Manhole # S33AA_025MH

Insp Date: **3/4/08 10:48 AM**

Location Address: **REAR OF 807 CATHEDRAL ST**

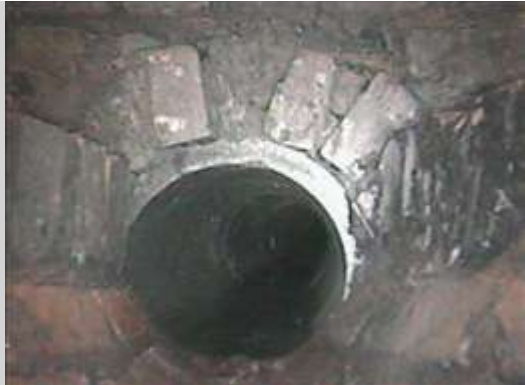
12 O'Clock Outflow

8 in. Circular Gravity Sewer
Pipe Out @ 12 O'Clock

Pipe Material: **Clay** ☐ Pipe Lined

Invert Depth: **11.35** (ft.) Flow Characteristics: **Slow**

Deposits: ☒ None ☐ Mud ☐ Sludge ☐ Debris ☐ Grease

Infiltration: **None** Pipe Seal Cond: **Sound**

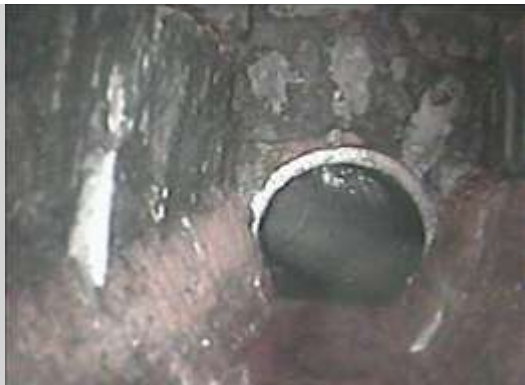
5 O'Clock Inflow

6 in. Circular Gravity Sewer
Pipe In @ 5 O'Clock

Pipe Material: **Clay** ☐ Pipe Lined

Invert Depth: **11.04** (ft.) Flow Characteristics: **Slow**

Deposits: ☒ None ☐ Mud ☐ Sludge ☐ Debris ☐ Grease

Infiltration: **None** Pipe Seal Cond: **Sound**

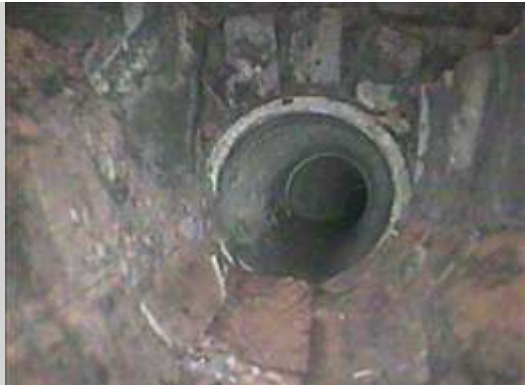
6 O'Clock Inflow

6 in. Circular Gravity Sewer

Pipe In @ 6 O'Clock

Pipe Material: **Clay** ☐ Pipe Lined

Invert Depth: **10.94** (ft.) Flow Characteristics: **Slow**

Deposits: ☒ None ☐ Mud ☐ Sludge ☐ Debris ☐ Grease

Infiltration: **None**

Pipe Seal Cond: **Sound**

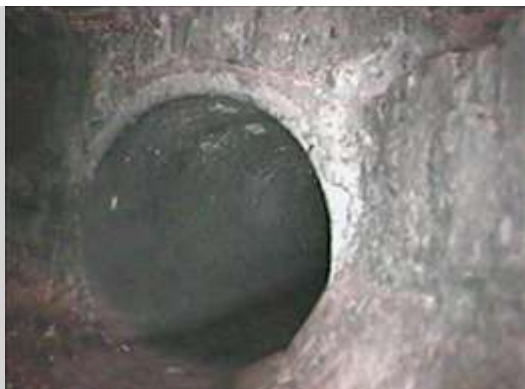
9 O'Clock Inflow

8 in. Circular Gravity Sewer

Pipe In @ 9 O'Clock

Pipe Material: **Clay** ☐ Pipe Lined

Invert Depth: **11.31** (ft.) Flow Characteristics: **Slow**

Deposits: ☒ None ☐ Mud ☐ Sludge ☐ Debris ☐ Grease

Infiltration: **None**

Pipe Seal Cond: **Sound**
